**RE: Severe Ice Damage to HTL Lining System
Creating Serious Threat to the Safety / Life of Personnel**

**HIGH TEMPERATURE LININGS
ICE DAMAGED LININGS
February 26, 2009**

TYPES OF TILE FAILURES CAUSED BY EXPANSION OF ICE BEHIND LINING

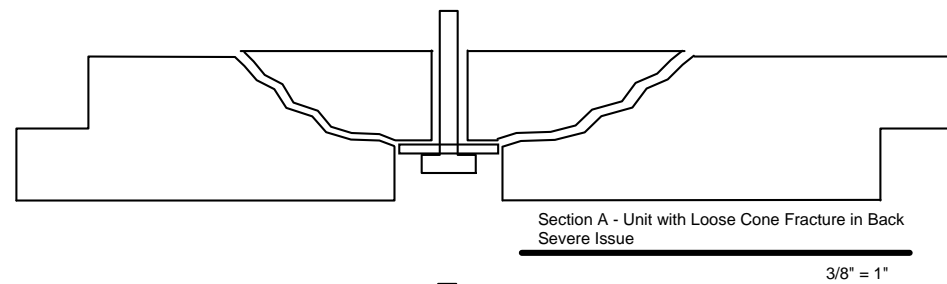
Anchor is still supporting tile but the tile has little strength left. Room should be closed off until leaks are corrected and repairs are completed. Problem might be identified by dampness, the existence of efflorescence and/or a crack that can be seen around the bottom of the bolt hole after the washer has been removed.

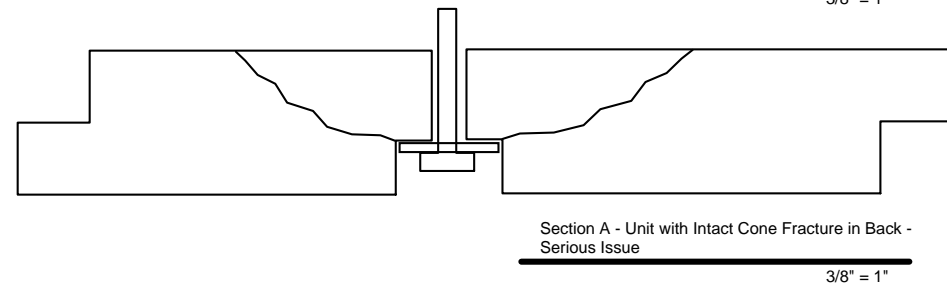
This tile is still supported by the anchor and the tile is able to support itself. You cannot detect this crack by inspecting the bolt hole. However, this crack only occurs if the adjacent tiles have been pushed away from the ceiling by the ice and "pry" against this tile, causing the crack. This tile will be found and replaced during the process to replace those tile with cone cracks shown above.
