**RE: Severe Ice Damage to HTL Lining System  
Creating Serious Threat to the Safety / Life of Personnel**

**HIGH TEMPERATURE LININGS  
ICE DAMAGED LININGS  
February 26, 2009**

**TYPES OF TILE FAILURES CAUSED BY EXPANSION OF ICE BEHIND LINING**

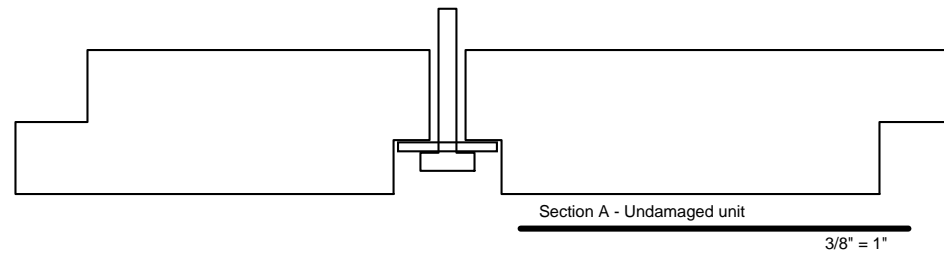
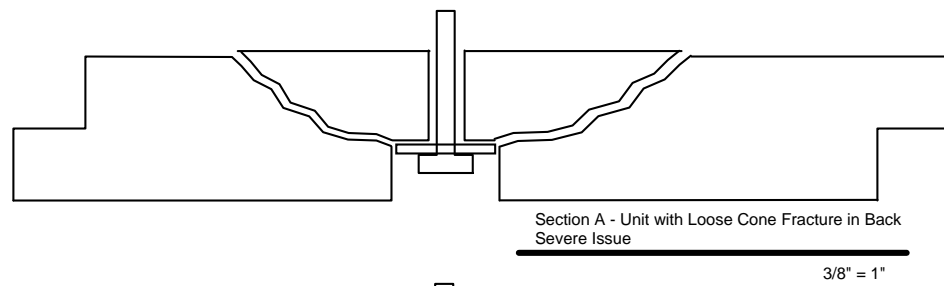
Anchor is no longer supporting tile. This is a severe issue and room should be closed off until leaks are corrected and repairs are completed. Problem might be identified by dampness, the existence of efflorescence and/or a gap, or a crack that can be seen around the bottom of the bolt hole after the washer has been removed.

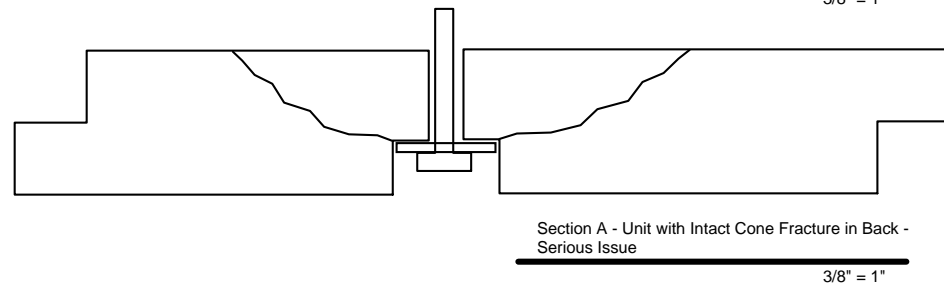
Anchor is still supporting tile but the tile has little strength left. Room should be closed off until leaks are corrected and repairs are completed. Problem might be identified by dampness, the existence of efflorescence and/or a crack that can be seen around the bottom of the bolt hole after the washer has been removed.

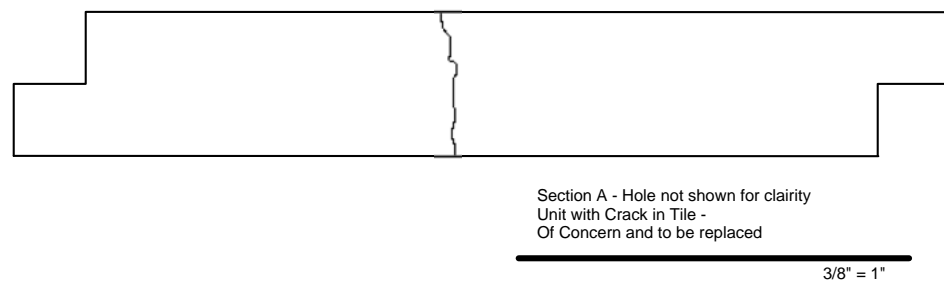
This tile is still supported by the anchor and the tile is able to support itself. You cannot detect this crack by inspecting the bolt hole. However, this crack only occurs if the adjacent tiles have been pushed away from the ceiling by the ice and "pry" against this tile, causing the crack. This tile will be found and replaced during the process to replace those tile with cone cracks shown above.
