**RE: Severe Ice Damage to HTL Lining System
Creating Serious Threat to the Safety / Life of Personnel**

**HIGH TEMPERATURE LININGS
ICE DAMAGED LININGS
February 26, 2009**

TYPES OF TILE FAILURES CAUSED BY EXPANSION OF ICE BEHIND LINING

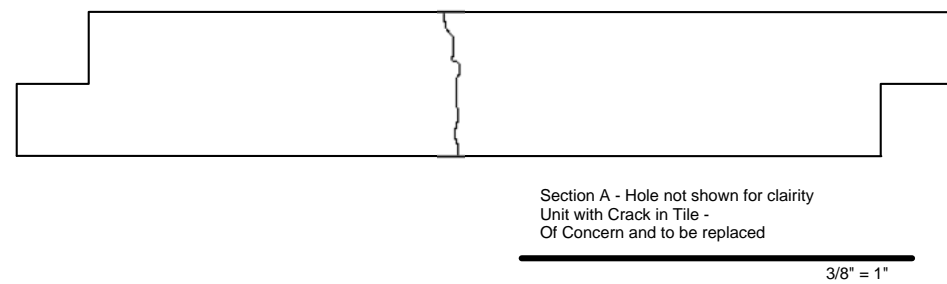
Anchor is no longer supporting tile. This is a severe issue and room should be closed off until leaks are corrected and repairs are completed. Problem might be identified by dampness, the existence of efflorescence and/or a gap, or a crack that can be seen around the bottom of the bolt hole after the washer has been removed.
