**RE: Severe Ice Damage to HTL Lining System  
Creating Serious Threat to the Safety / Life of Personnel**

**HIGH TEMPERATURE LININGS  
ICE DAMAGED LININGS  
February 26, 2009**

**TYPES OF TILE FAILURES CAUSED BY EXPANSION OF ICE BEHIND LINING**

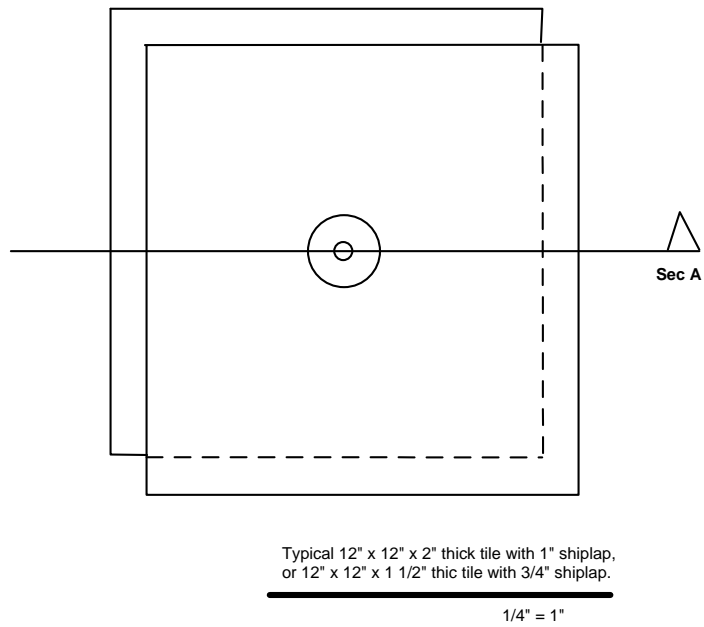
Anchor is no longer supporting tile. This is a severe issue and room should be closed off until leaks are corrected and repairs are completed. Problem might be identified by dampness, the existence of efflorescence and/or a gap, or a crack that can be seen around the bottom of the bolt hole after the washer has been removed.

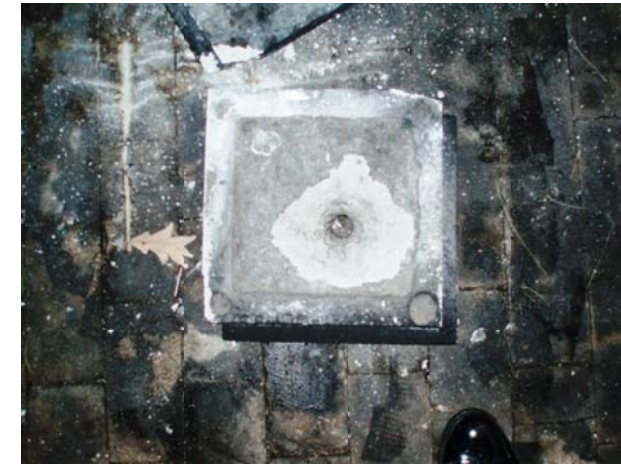
Anchor is still supporting tile but the tile has little strength left. Room should be closed off until leaks are corrected and repairs are completed. Problem might be identified by dampness, the existence of efflorescence and/or a crack that can be seen around the bottom of the bolt hole after the washer has been removed.

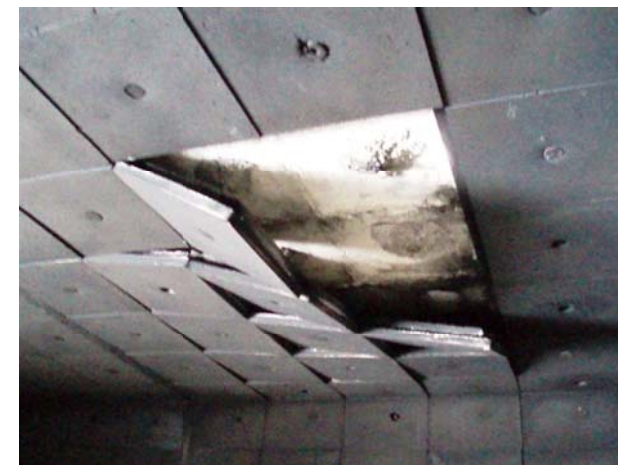
This tile is still supported by the anchor and the tile is able to support itself. You cannot detect this crack by inspecting the bolt hole. However, this crack only occurs if the adjacent tiles have been pushed away from the ceiling by the ice and "pry" against this tile, causing the crack. This tile will be found and replaced during the process to replace those tile with cone cracks shown above.
